Manhole Inspection Summary

Manhole # S53AA_034MH

Insp Date: **7/16/08 3:13 PM**

Location Address: **3300 mcelderry st**

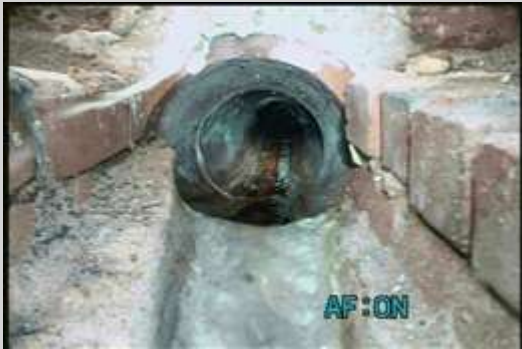
12 O'Clock Outflow

8 in. Circular Gravity Sewer
Pipe Out @ 12 O'Clock

Pipe Material: **Clay** ☐ Pipe Lined

Invert Depth: **5.89** (ft.) Flow Characteristics: **Fast**

Deposits: ☒ None ☐ Mud ☐ Sludge ☐ Debris ☐ Grease

Infiltration: **None** Pipe Seal Cond: **Unknown**

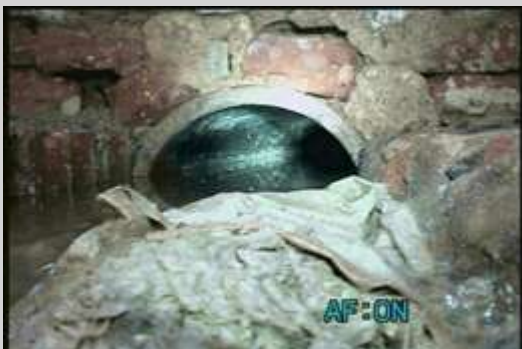
6 O'Clock Inflow

8 in. Circular Gravity Sewer
Pipe In @ 6 O'Clock

Pipe Material: **Clay** ☐ Pipe Lined

Invert Depth: **5.81** (ft.) Flow Characteristics: **Slow**

Deposits: ☒ None ☐ Mud ☐ Sludge ☐ Debris ☐ Grease

Infiltration: **None** Pipe Seal Cond: **Unknown**

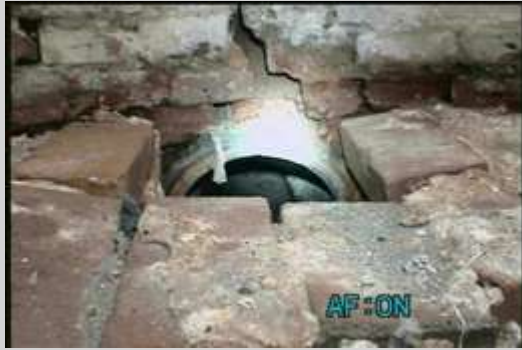
9 O'Clock Inflow

8 in. Circular Gravity Sewer

Pipe In @ 9 O'Clock

Pipe Material: **Clay** ☐ Pipe Lined

Infiltration: **None** Pipe Seal Cond: **Unknown**
